Superfund Record of Decision (EPA Region 3)
Harvey-Knott Drum Site
New Castle County, Delaware, September 1985

EPA/ROD/R03-85/017
September 1985

RECORD OF DECISION
REMEDIAL ALTERNATIVE SELECTION

Site: Harvey and Knott Drum Site
New Castle County, Delaware

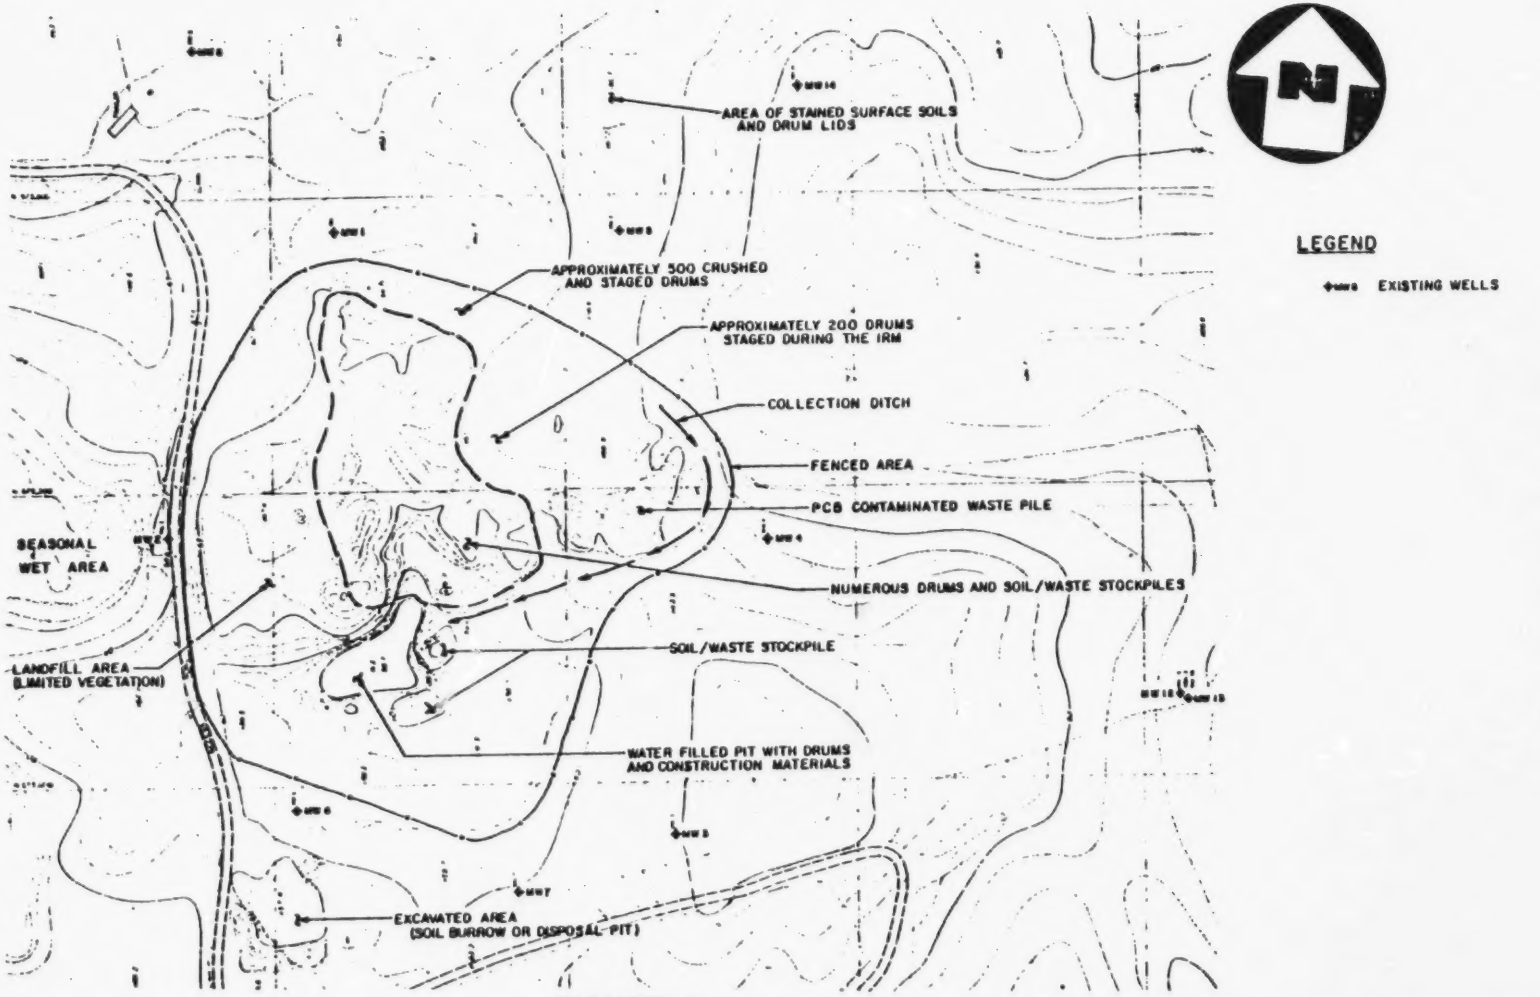
FIGURE 4

Site conditions (Figure 4) as encountered prior to the Remedial Investigation can be characterized as follows:

- An area of approximately 2.5 acres had been fenced to prevent access to drums and an open pond.
- Stockpiles of empty to full drums in various states of deterioration, were located within the fenced area.

- An area west of the fenced area, which receives surface runoff from the fenced area, showed evidence of stressed vegetation. However, this area is also poorly drained, a factor which could cause this condition.

Approximately 500 drums that were identified as being empty were characterized, crushed, and staged within the fenced area. Another 200 drums that were partially to entirely full are staged in another area within the fenced area. The central zone of the fenced area still has numerous drums that have not been staged and characterized to determine whether they contain any hazardous wastes.

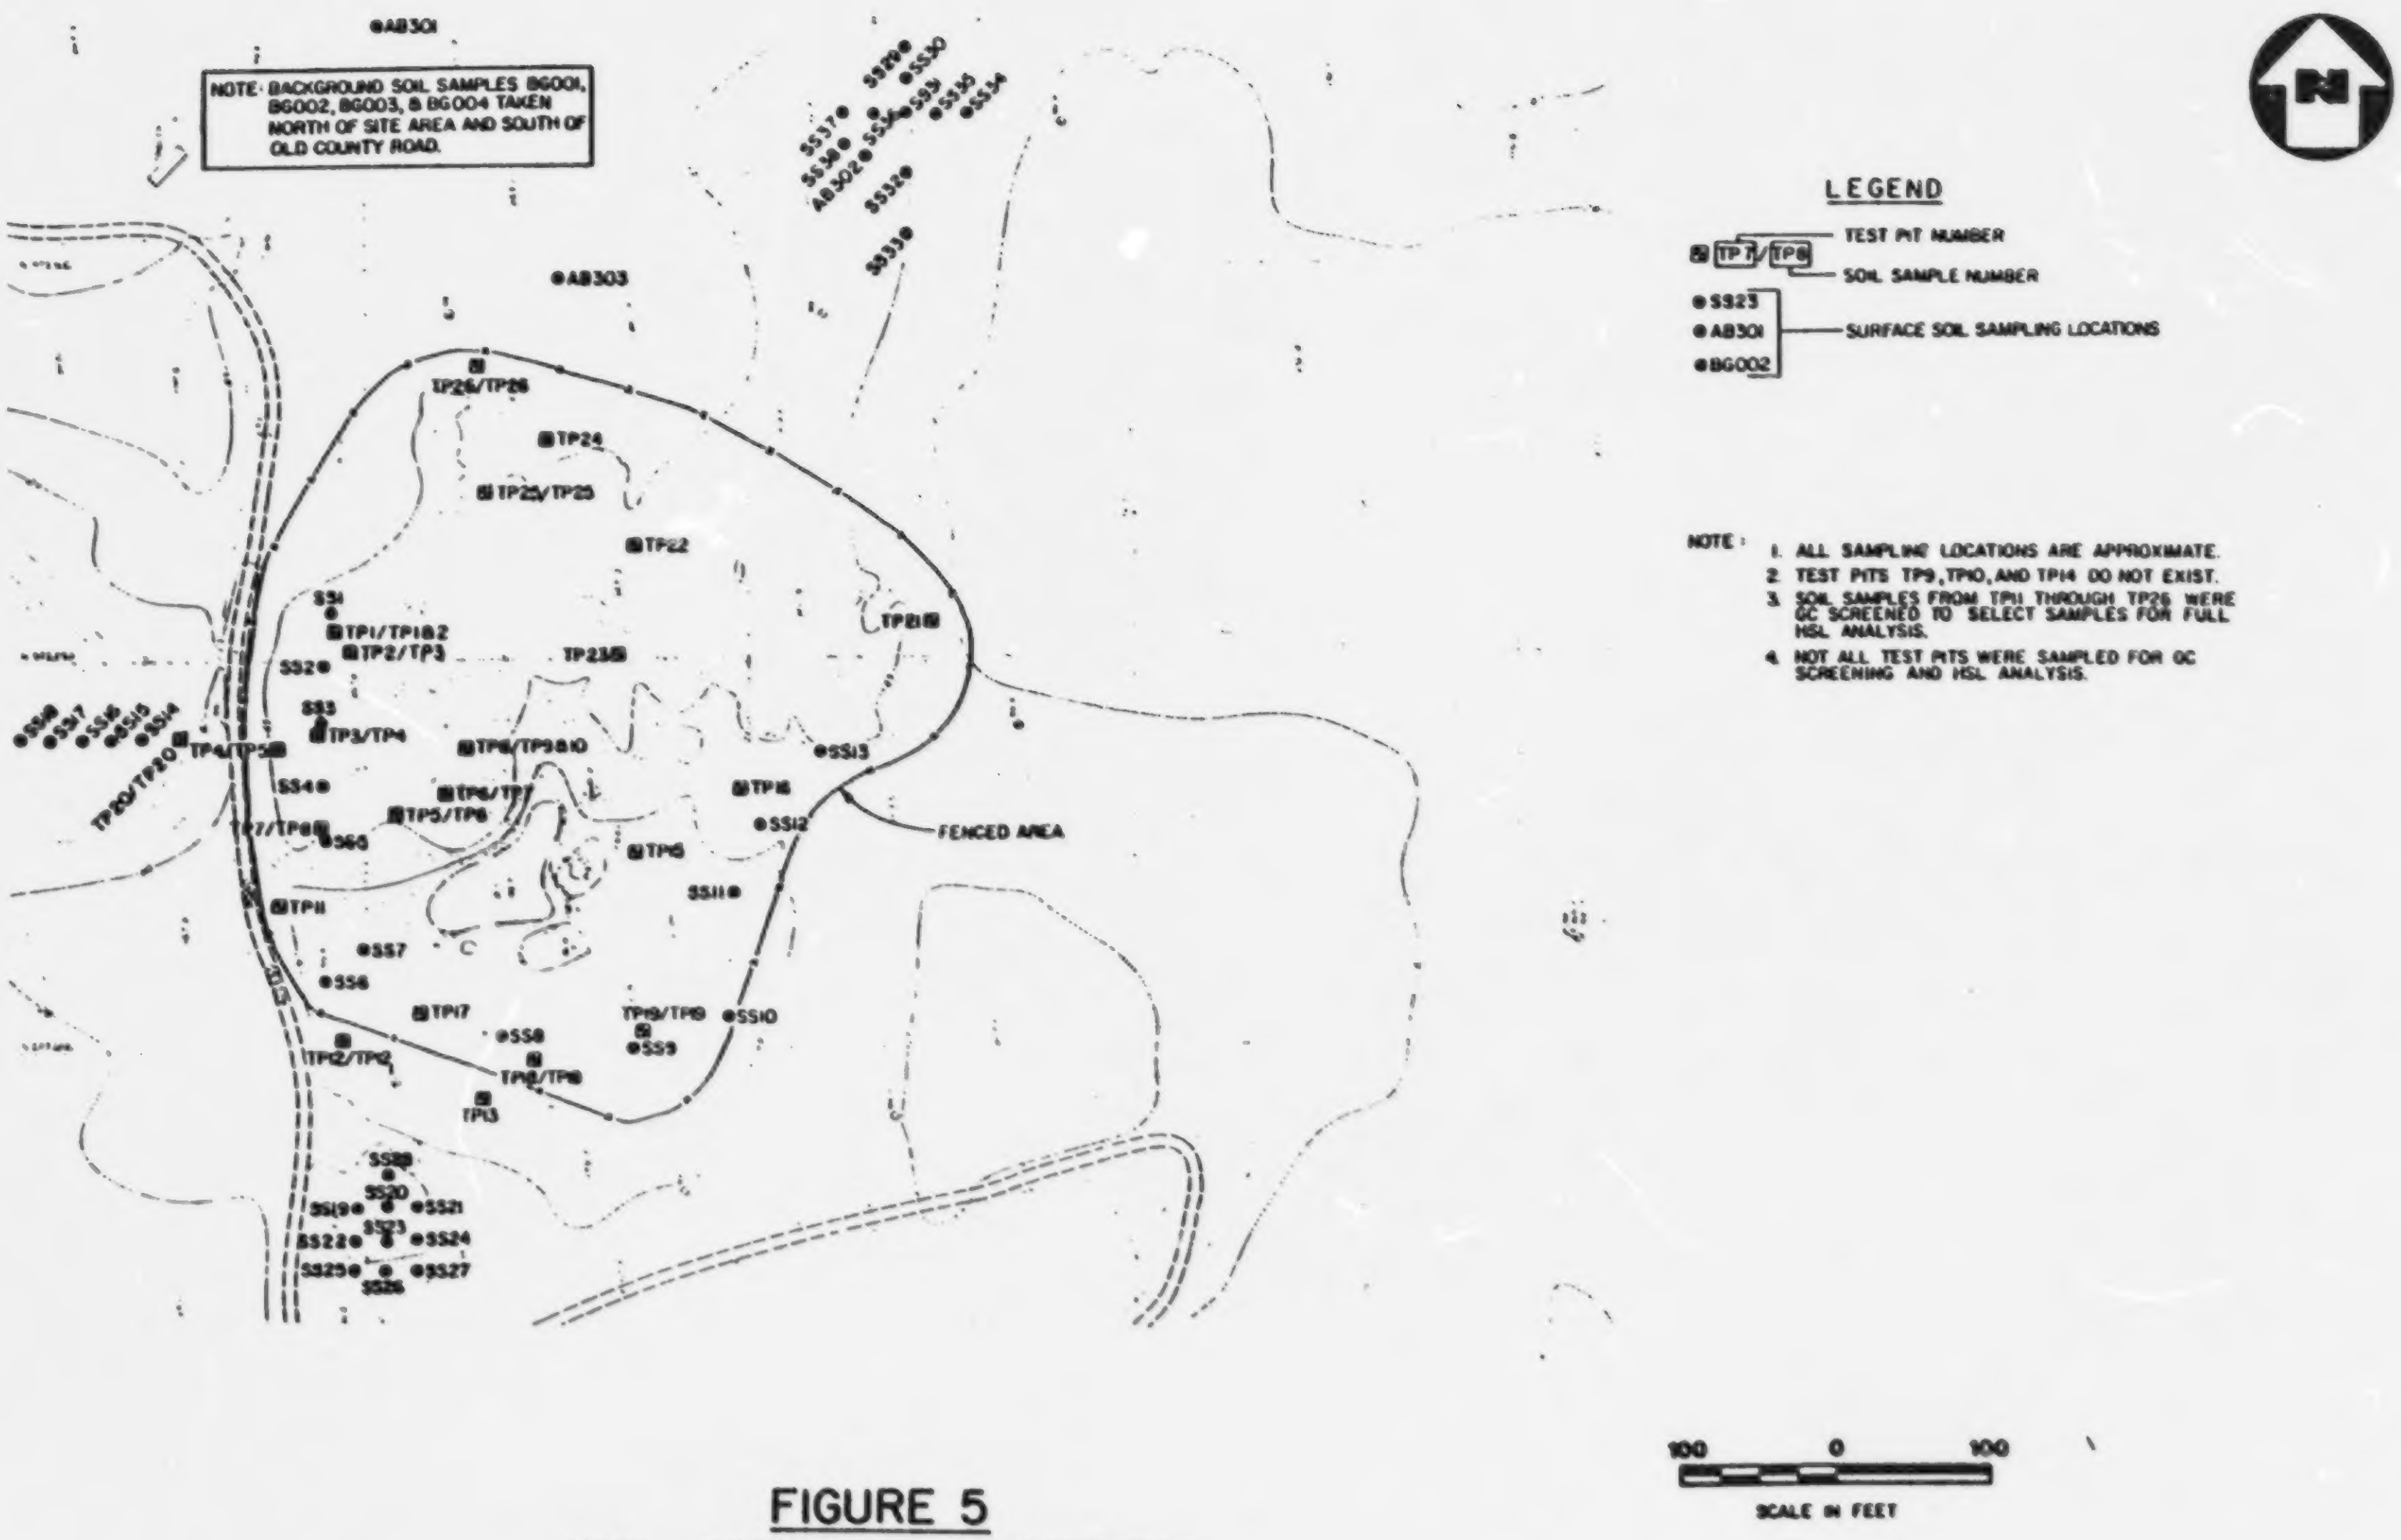
FIGURE 5
SOIL SAMPLING LOCATIONS
HARVEY AND KNOTT DRUM SITE, KIRKWOOD, DE

Surface and subsurface soil sampling locations are shown on figure 5. A number of Hazardous Substances List (HSL) organic compounds and inorganic elements were detected. Organic compounds include: volatile organics (halogenated aliphatics, monocyclic aromatics, and ketones); semi-volatile organics (phthalate esters, phenols, and amines); pesticides; and PCBs. Trace elements include all those on the HSL.

As indicated on Table 1, volatile contamination (numbers 1 through 5) was prevalent in high concentrations particularly in subsurface samples. The most highly contaminated soils were found in test pits 12(at a depth of 7 ft.), TP-17(8 ft.) and TP-18(4 ft.) on the southern periphery of the fenced area and also TP 20(3 and 6 ft.) just outside the western fence limit. Surface soils generally exhibited 100 to 1,000 times less than the volatile contamination found in subsurface soils. This could be attributed to

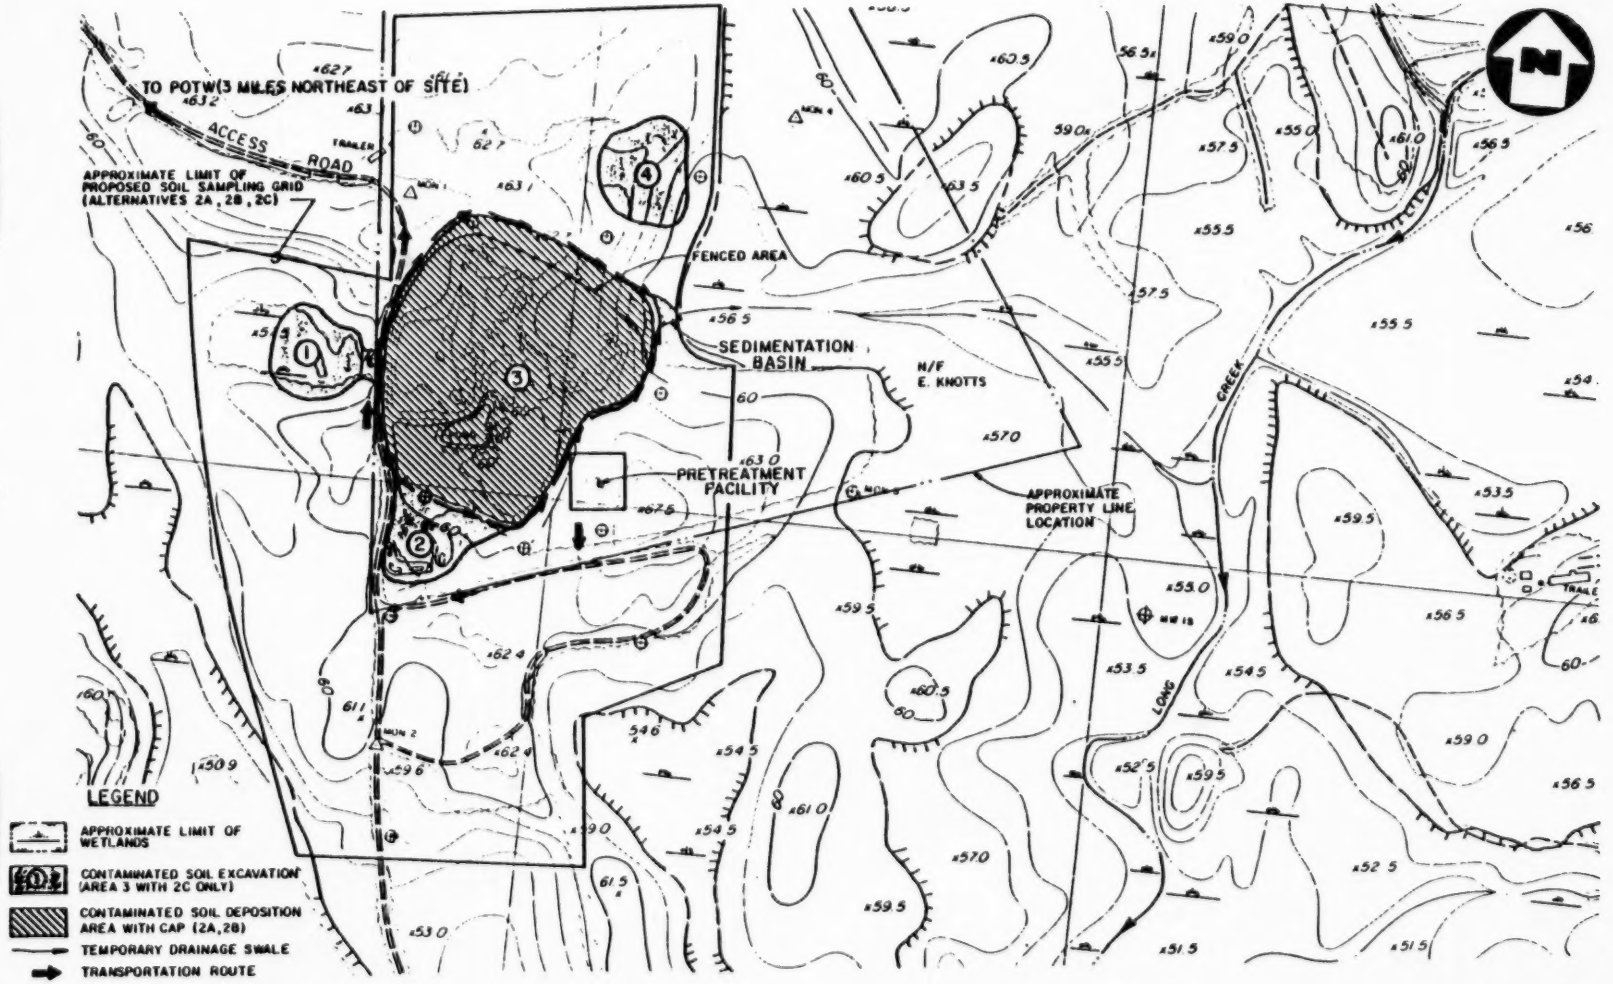
FIGURE II

Based upon results of previous site investigations, the areas of greatest surface and subsurface soil contamination are delineated on figure 11. Alternatives 2A and 2B include excavating soils in areas Nos. 1, 2, and 4, placing these soils into area Nos. 3, and capping onsite. Alternative 2C proposes to excavate areas 1, 2, 3, and 4 and dispose offsite in a RCRA Hazardous Wastes Management Facility.

Remedial Action Alternatives 2A, 2B, and 2C were developed to meet the CERCLA objective of protecting public health, welfare, and the environment by reducing present or future threats from hazardous substances. The intent of these alternatives is to reduce the migration of contaminants by providing surface cleanup actions consisting of onsite pond cleanup, pond water treatment, drum and bulk waste removal followed by offsite disposal, and contaminated soil excavation. Excavated materials will either be disposed onsite and capped or hauled offsite to a permitted Hazardous Waste Management Facility.

These remedial action alternatives are a combination of several remedial components and have common elements except for (a) the volume of excavated material and (b) its final disposed. Alternatives 2A and 2B include partial removal and onsite capping actions, whereas Alternative 2C is a complete removal/offsite disposal response.
